# Can Implant-retained Overdenture Components Cause Damage to the Opposing Natural Dentition?

**Dent Update 2021; 48: 571–578**

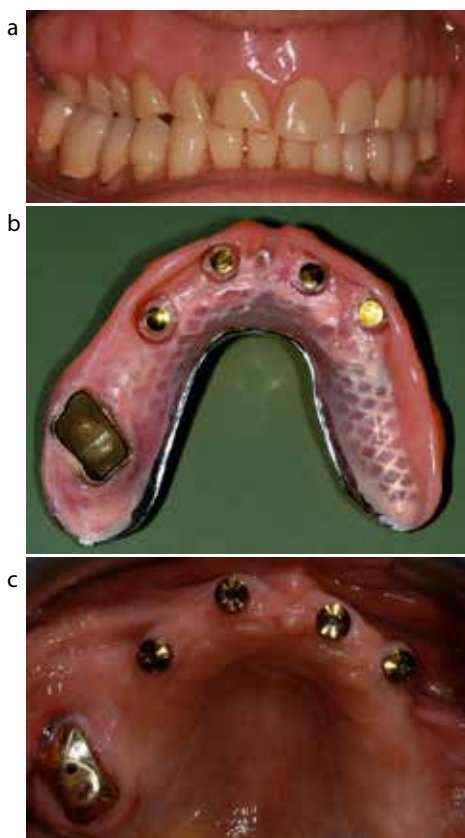
**Figure 1. Case 1:** (a) pre-operative labial view showing worn upper implant-retained denture. (b) Pre-operative fit surface of denture with magnet and housing for telescopic crown. (c) Pre-operative upper occlusal view

A 71-year-old male presented in 2004 with a maxillary overdenture supported by four implants with magnets, and an upper molar telescopic Konus crown. This was opposed by conventional and implant-retained crowns in the lower arch (Figure 1). In 2012, the UL3 magnet had displaced and shortly after, the UR4 magnet was lost (Figure 2). The patient was aware of daytime grinding, which had resulted in extreme wear of the magnets, keepers and occlusal surface on the denture. A treatment plan was agreed to replace the existing overdenture with a bar-retained overdenture at an increased occlusal vertical

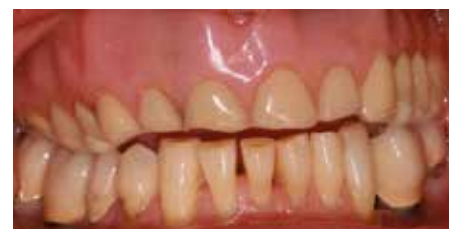
**Figure 3. Case 1:** use of existing overdenture to increase the vertical dimension.

dimension. The existing denture was initially used to increase the vertical dimension by approximately 5 mm (Figure 3). Once satisfied with the occlusal vertical dimension, a copy denture technique was applied to construct the new bar-retained overdenture (Figure 4). The prosthesis was successfully delivered to the patient; however, 3 years later, the patient complained of an aching sensation from his lower right teeth, which was worse in the mornings. The patient continued to show signs and symptoms of on-going bruxism. He was diligently taking his upper denture out at night, but as a result, the titanium bar was bruxing against his natural dentition. Clinical examination showed obvious signs of tooth wear on the lower anterior teeth. In particular, the pattern of wear on the lower right canine coincided perfectly with the shape of the upper bar (Figure 5).

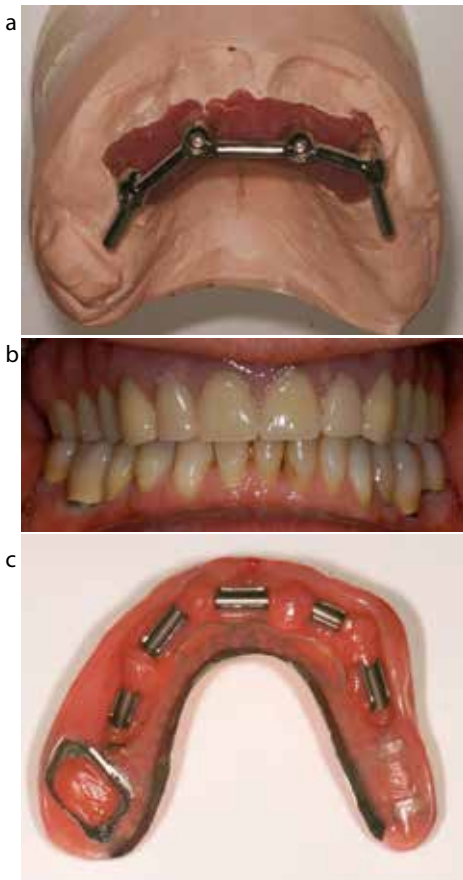
**Figure 4. Case 1:** (a) replacement of magnet locators with an upper implant retained bar. (b) Post-operative labial view. (c) Post-operative fit surface of upper bar-retained implant overdenture

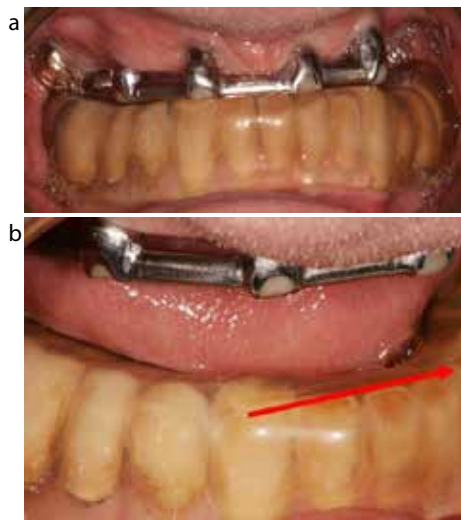
**Figure 6. Case 1:** (a) soft splint on the lower teeth to provide protection when overdenture not being worn. (b) Wear marks evident on soft splint from opposing bar at review.

To prevent further damage to the opposing dentition, it was agreed to provide the patient with a nighttime splint. A soft splint was made for the lower teeth to separate the bar away from the natural dentition and act as a shock absorber. At subsequent review, the patient was pain-free with no further signs of wear on his natural teeth, although wear marks were seen on the soft splint (Figure 6).

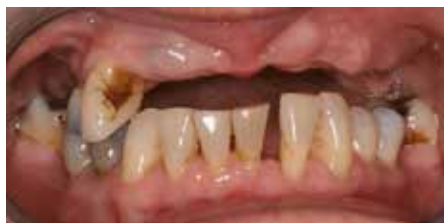
**Figure 8. Case 2:** extraction of poor prognosis teeth; uneven lower occlusal plane evident prior to orthodontic treatment

Initial non-surgical periodontal therapy was completed along with extraction of several hopeless prognosis teeth. At this stage, few strategic teeth were retained to help stabilize an upper immediate denture (Figure 8). After discussing options with the patient, a decision was made to have an implant bar-retained complete maxillary overdenture. Four implants were placed with simultaneous sinus grafting, along with extraction of the remaining teeth in the maxilla. Other treatment consisted of mandibular molar implants and orthodontics to improve inter-occlusal space for the provision of a maxillary titanium bar. Fixed prosthodontic treatment was completed, followed by provision of the final maxillary bar-retained overdenture (Figure 9). The patient was provided with a vacuum-formed

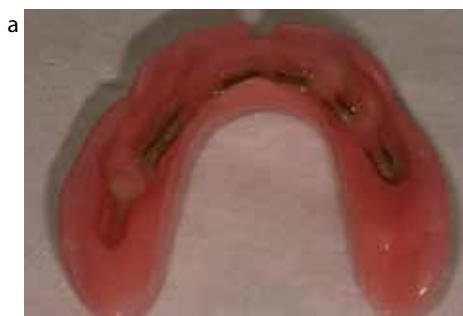
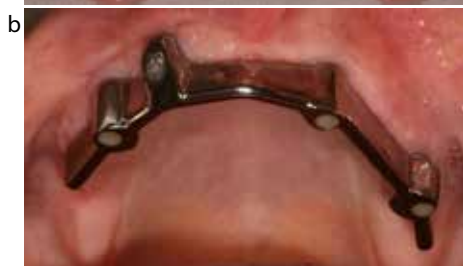
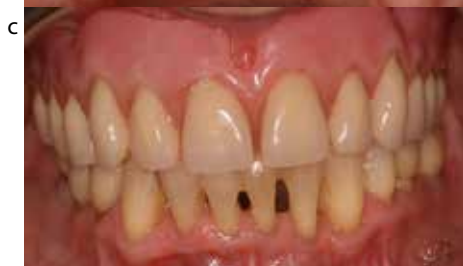
**Figure 9. Case 2:** (a) post-operative upper implant-retained bar overdenture. (b) Post-operative implant-retained upper titanium bar. (c) Post-operative labial view of upper implant-retained overdenture.

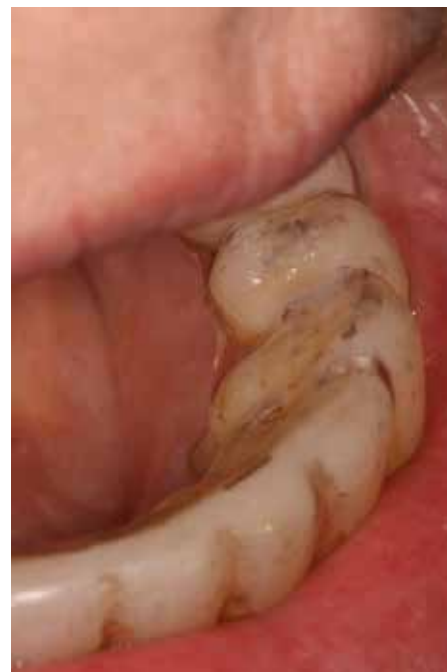
**Figure 10. Case 2:** obvious signs of wear on the lower orthodontic retainer on the anterior teeth.

At 6-month review, obvious signs of wear were present on the orthodontic retainer (Figure 10). On assessing the occlusion without the denture, as it would be every night, it was obvious the titanium bar was contacting the lower left anterior teeth and therefore a potential risk for tooth surface loss (Figure 11). In order to protect the lower teeth from the bar bruising against the natural dentition, a thicker vacuum-formed soft splint (Figure 12) was provided to wear at night, which was well tolerated and provided good protection to the dentition.

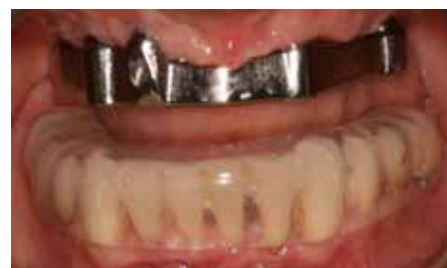
**Figure 12. Case 2.** Thicker vacuum-formed soft splint provided to prevent risk of wear of natural dentition from opposing bar.

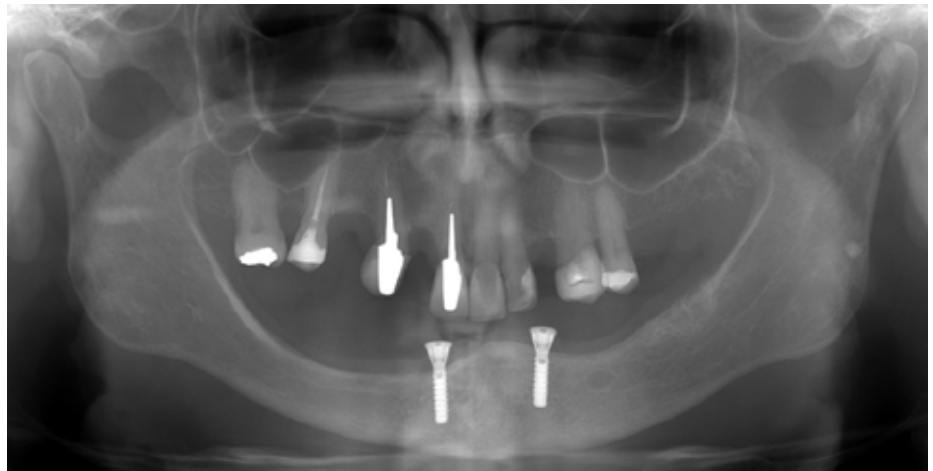
**Figure 14. Case 3:** OPG radiograph showing lower canine implants *in situ* and root angulation of UR3 in relation to crown.

rather than dental implants or a new removable partial denture in the maxillary arch. The UR3, which needed a cast post, was deemed to be at risk of potential root fracture due to the crown to root angle and, therefore, it was deemed essential to design a bridge with potential future tooth loss in mind (Figure 14). A fixed-movable four-piece bridge was designed (Figure 15) and provided in the upper arch, and a locator-retained lower overdenture in the lower arch (Figure 16).

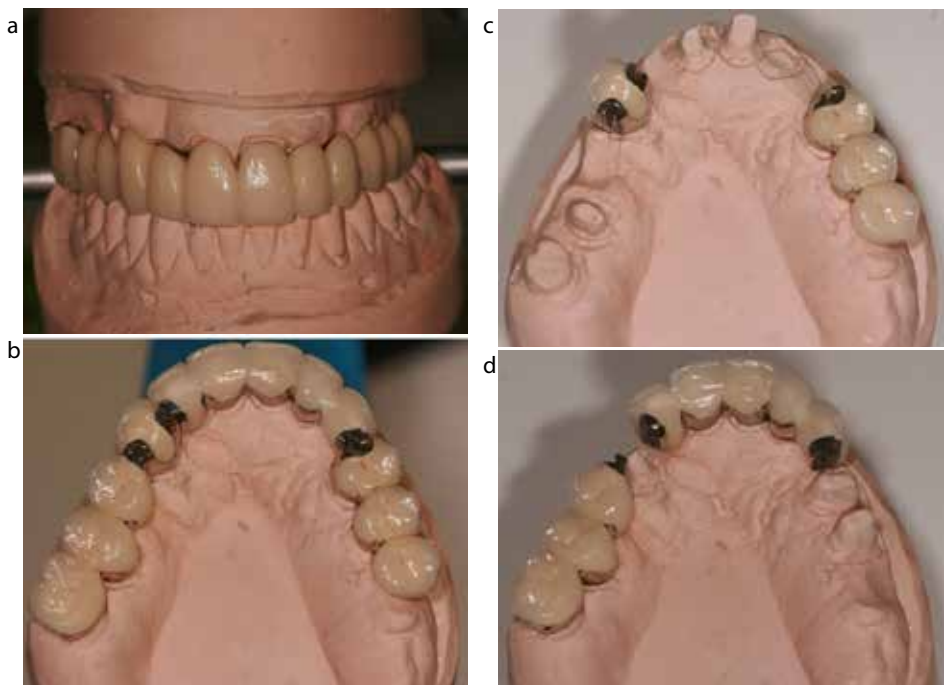
**Figure 15. Case 3:** (a) fixed-movable four-piece bridge designed for upper arch. (b) Occlusal view of fixed-movable full arch upper bridge. (c) Female components of fixed-movable bridge. (d) Male components of fixed-movable bridge.

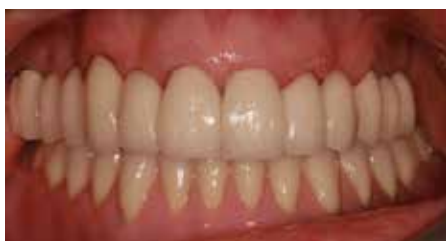
**Figure 16. Case 3:** Post-operative labial view with full arch upper bridge and lower implant-retained overdenture.

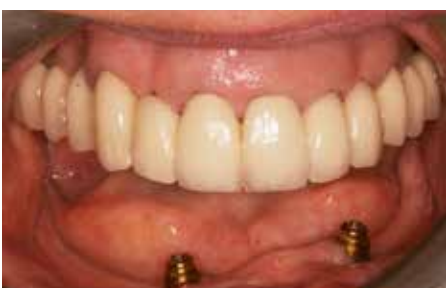
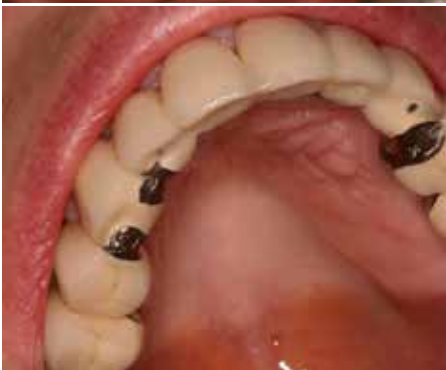
**Figure 18. Case 3:** (a) at review, space developed between UR2 pontic and soft tissue. (b) Male part of the fixed-movable joint on the mesial aspect of the UR3 sitting above the occlusal plane.

1 year later; by this time, the male part of the fixed-movable joint on the mesial aspect of the UR3 was sitting above the occlusal plane and a gap had appeared above the UR2 pontic (Figure 18). All of the bridgework otherwise was stable and teeth asymptomatic. Due to continued reports of discomfort in the UR3 area, a cone beam CT scan was prescribed; this also showed no pathology or fracture. Further discussion

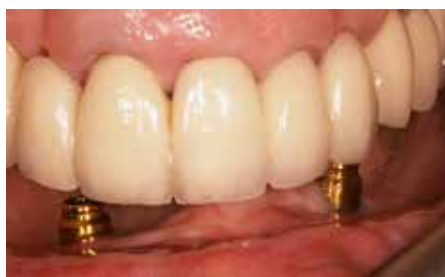
**Figure 19. Case 3:** without the lower denture *in situ*, the left locator sits higher than the right and is the only contact in occlusion.

with the patient revealed that she had been taking her denture out at night as instructed. Clinical assessment without the lower denture *in situ* showed that the lower left locator attachment was higher than the right side in contact in occlusion (Figure 19). Fine chipping of the porcelain was also noted on the incisal edge of the UL3.

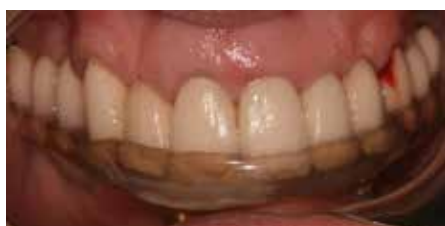
**Figure 20. Case 3:** upper hard splint made to provide more robust protection against opposing implant components.

UR3 through a fulcrum point in the upper central incisor region. This would explain why the pontic at UR2 had come away from the tissues. On discussion with the patient, it was decided to make an upper hard acrylic splint (Figure 20).
